Re: Rainier Commons Phase I Close Out Report – Supplement to Response to Request for Additional Information

Rainier Commons Exterior Paint Removal Project

Daily Observations & Activity Report

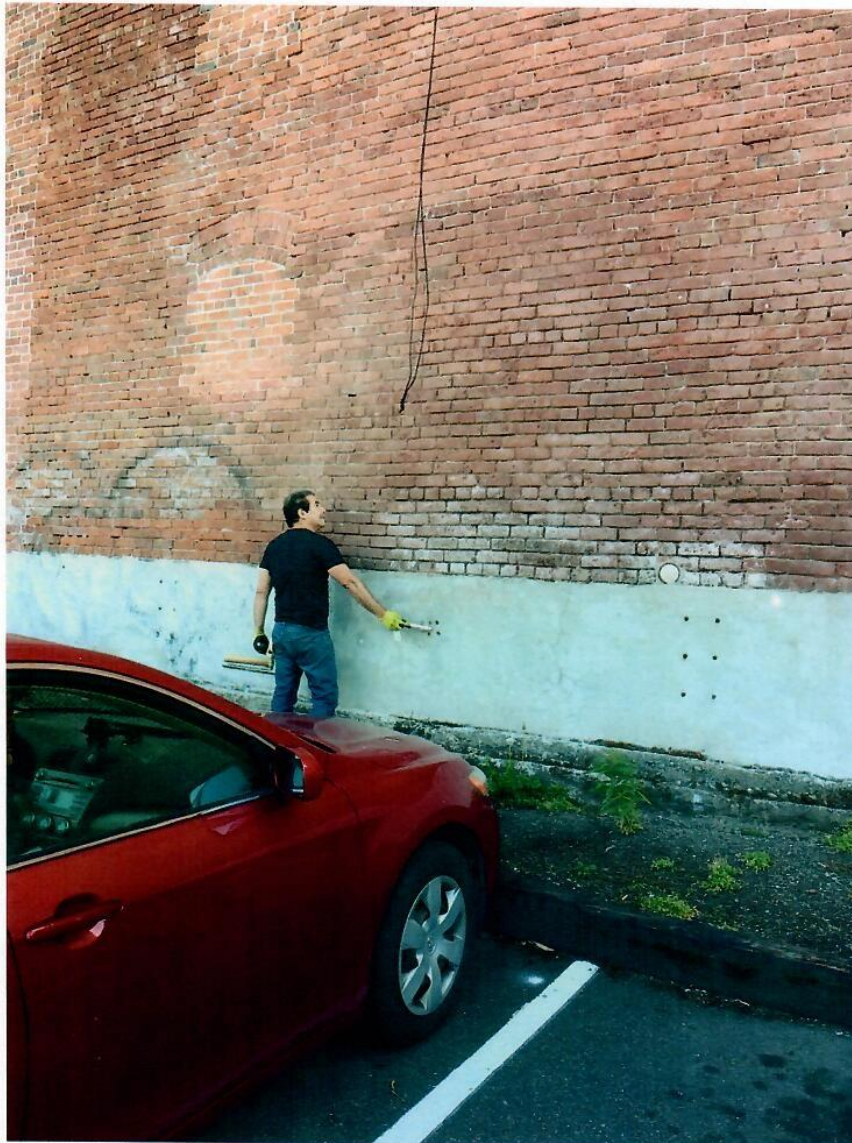
Location of previous concrete samples taken for the west elevation of Building 13

*On this and subsequent photographs, the blue cast/tinting is an artifact of the photographic process and is not indicative of actual colors.

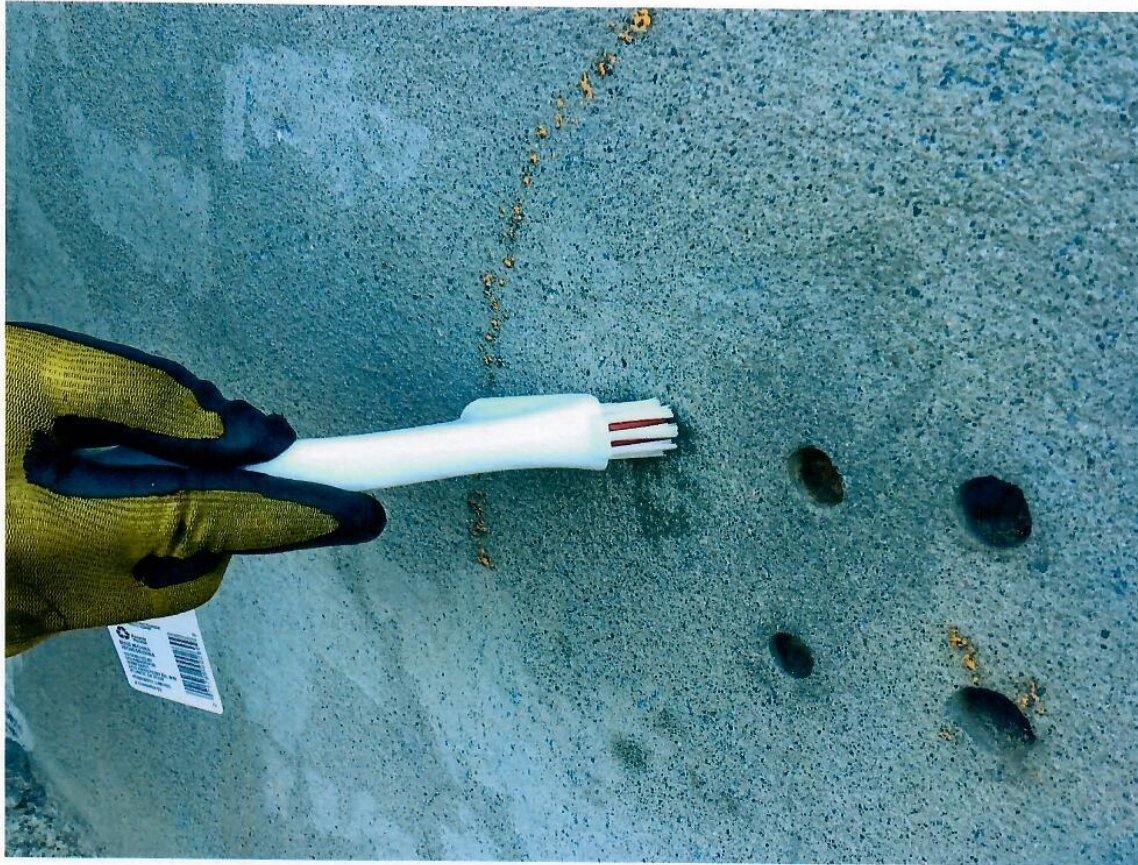
Cleaning of concrete substrate utilizing USEPA SOP for Sampling Porous Surfaces for Polychlorinated Biphenyls, Section 9.1.1

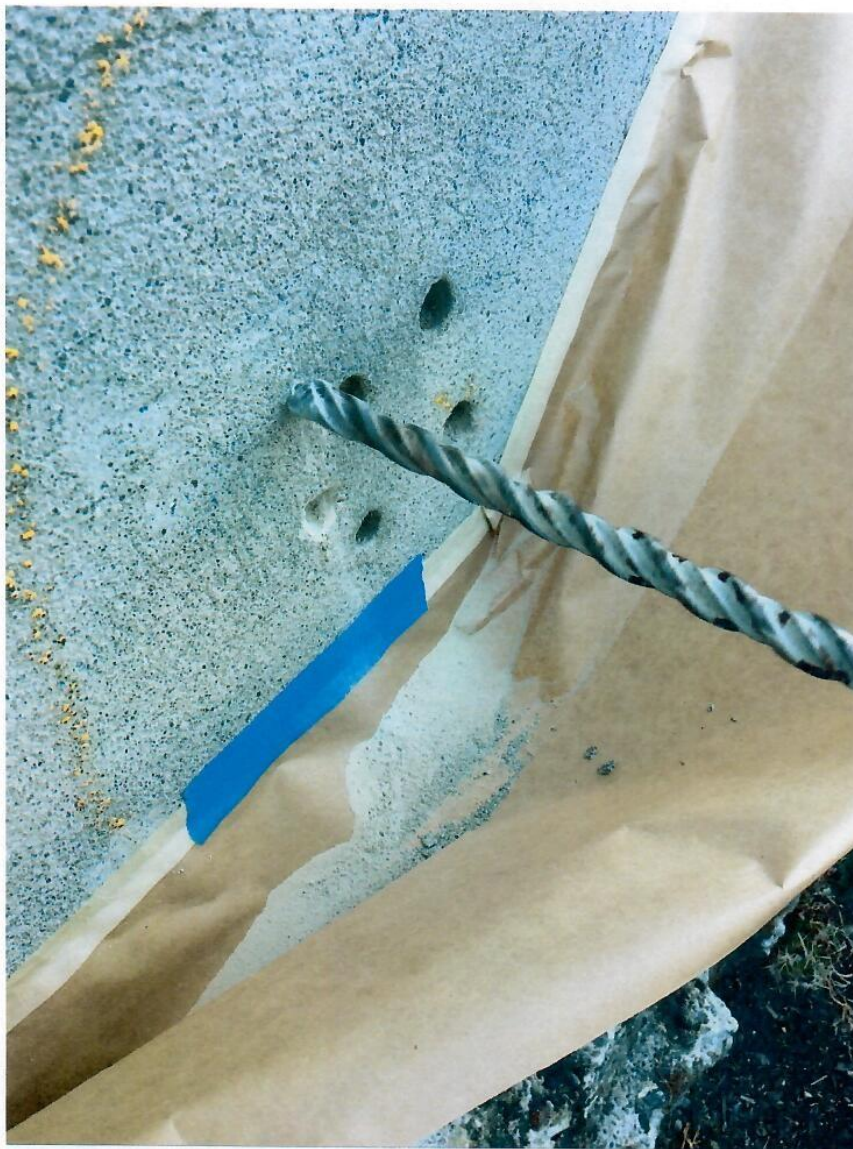
Collection of concrete substrate utilizing USEPA SOP for Sampling Porous Surfaces for Polychlorinated Biphenyls, Section 9.1.4. The retest samples were co-located with previous samples.

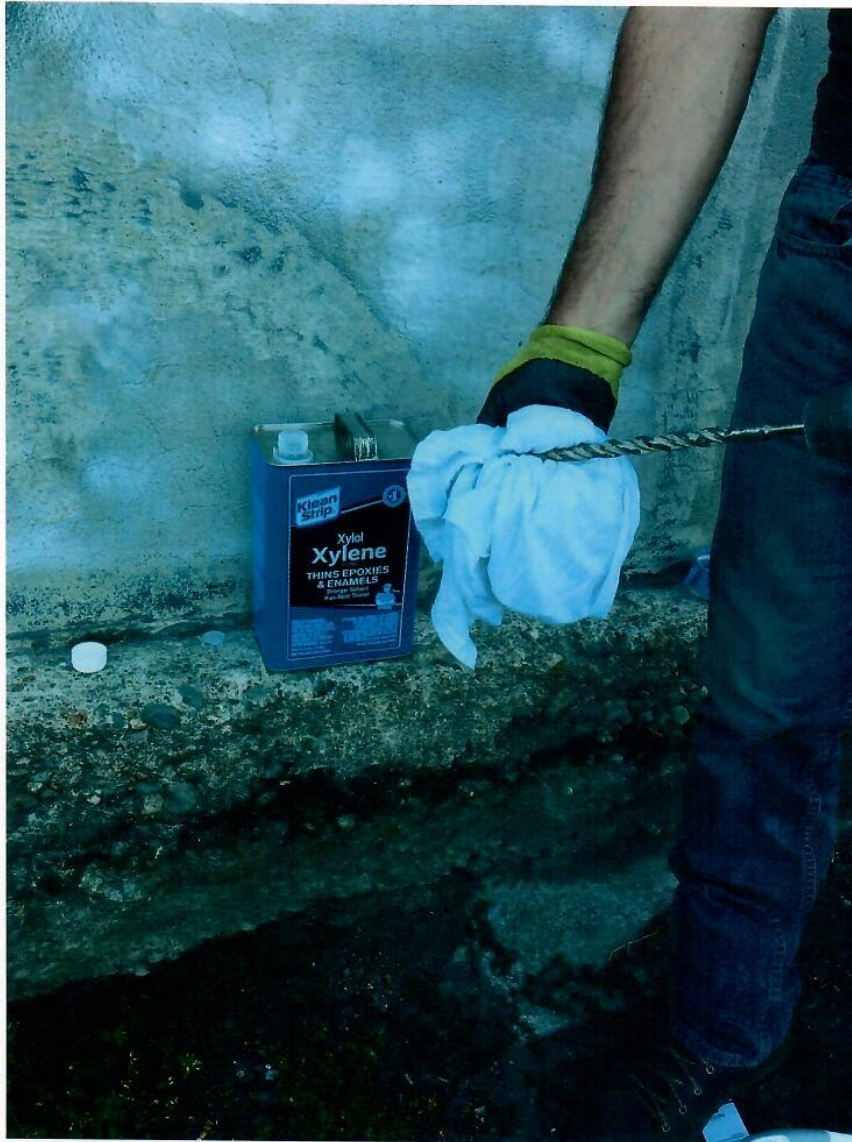
Cleaning roto-hammer bit after each sample to eliminate risk of cross-contamination between samples

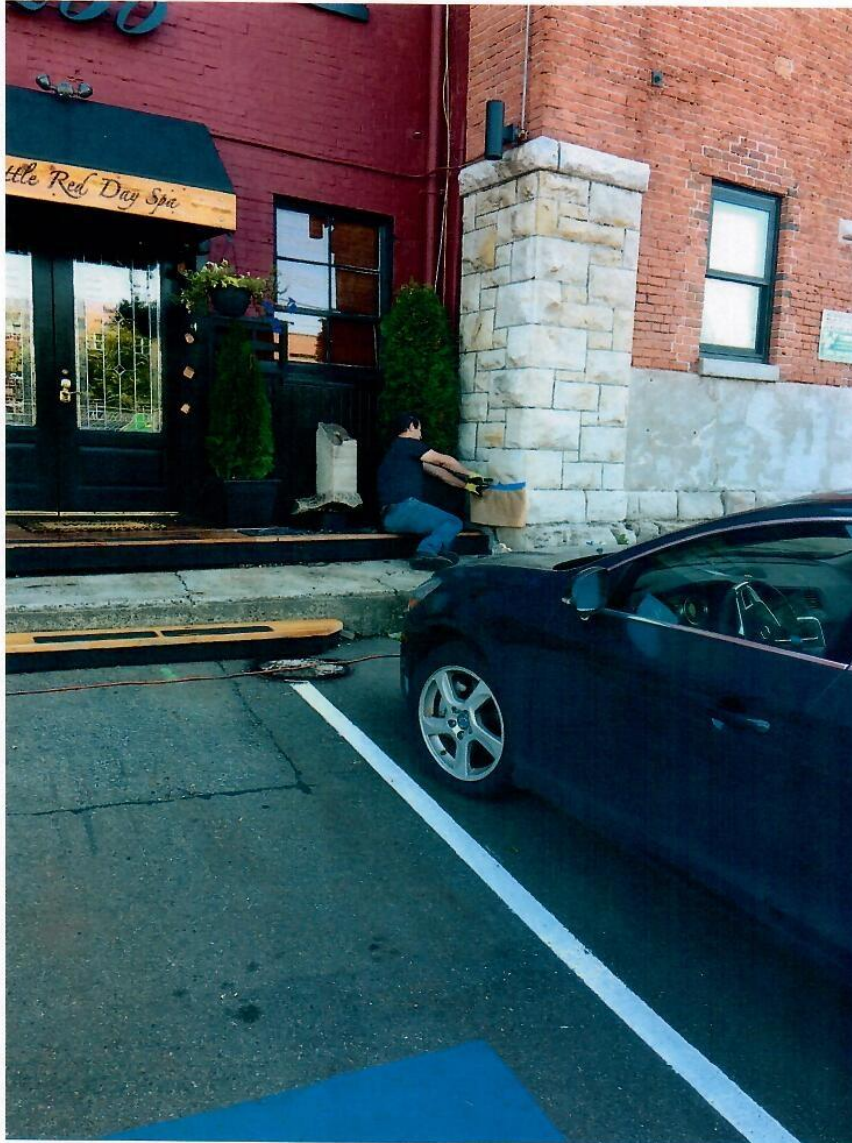
Location of sampling area on Building 11's west elevation.

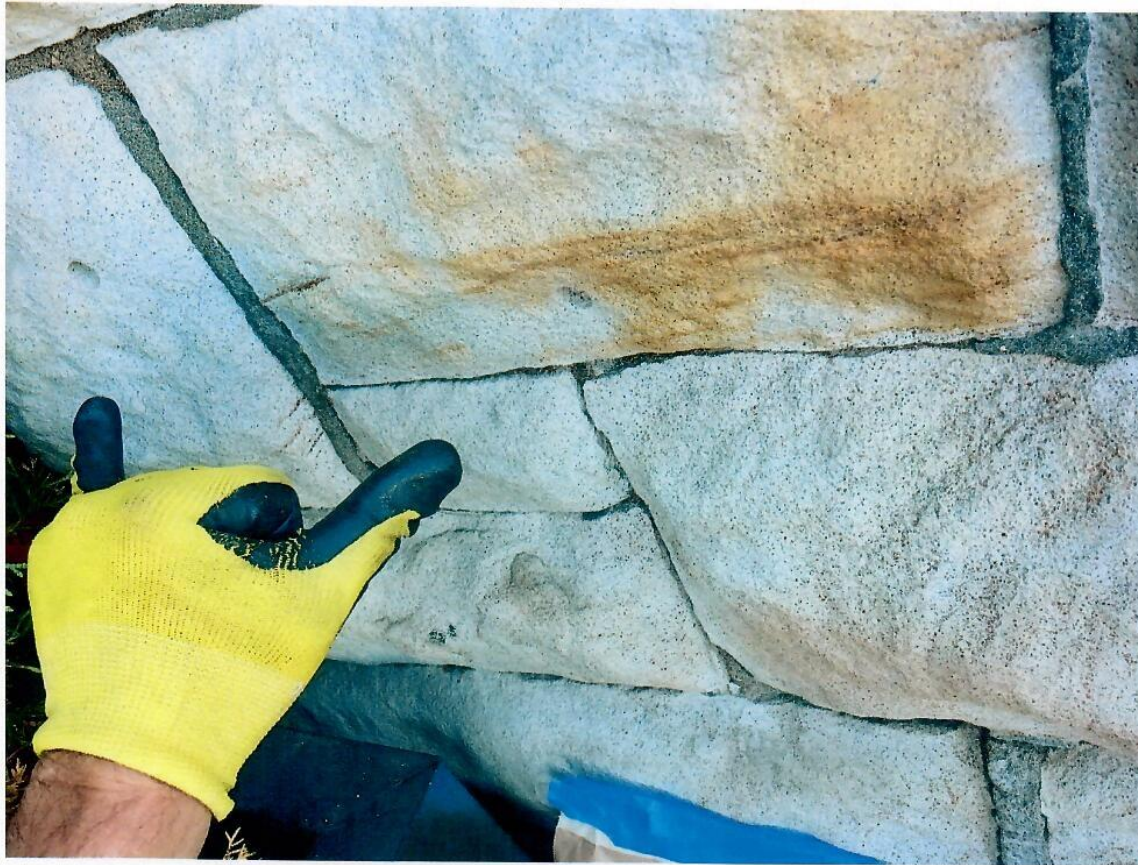
Previous sampling locations are identified by gloved hand. New sample to be taken just above the blue tape. Spacing between samples is for esthetic purposes.

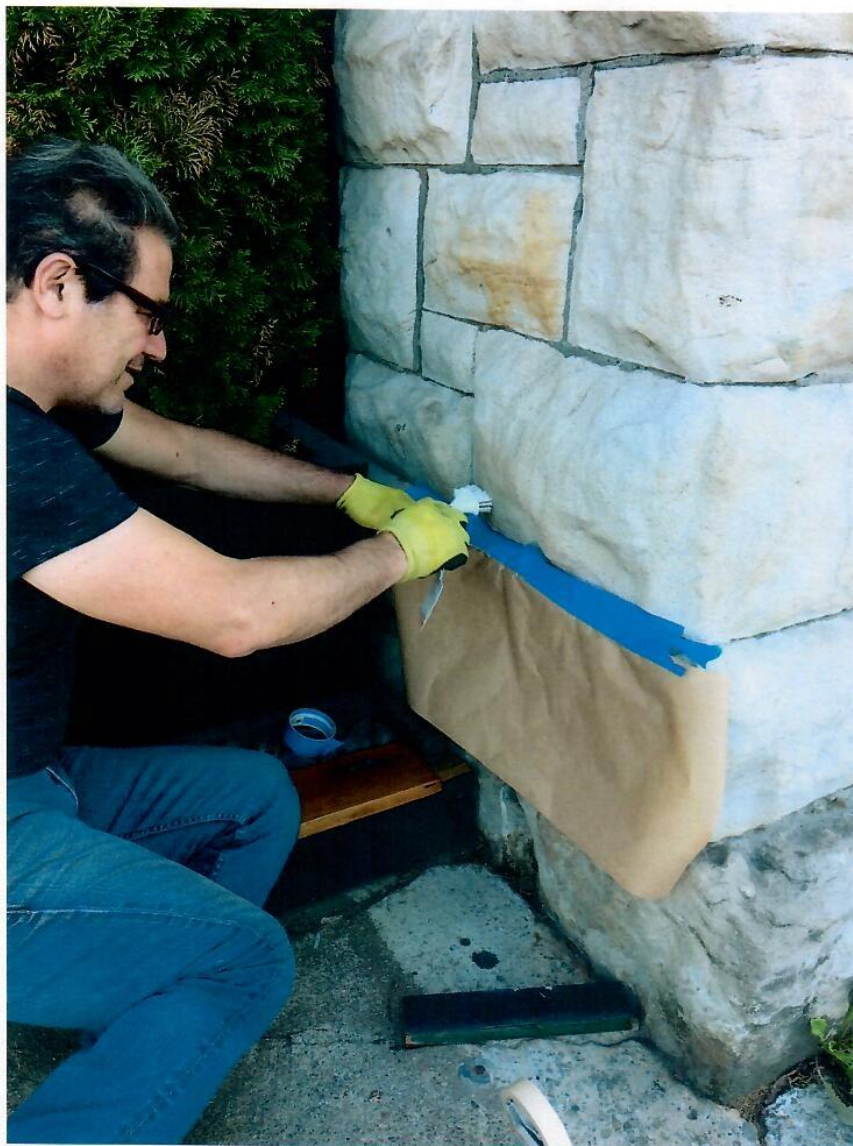
Cleaning of sandstone substrate utilizing USEPA SOP for Sampling Porous Surfaces for Polychlorinated Biphenyls, Section 9.1.1

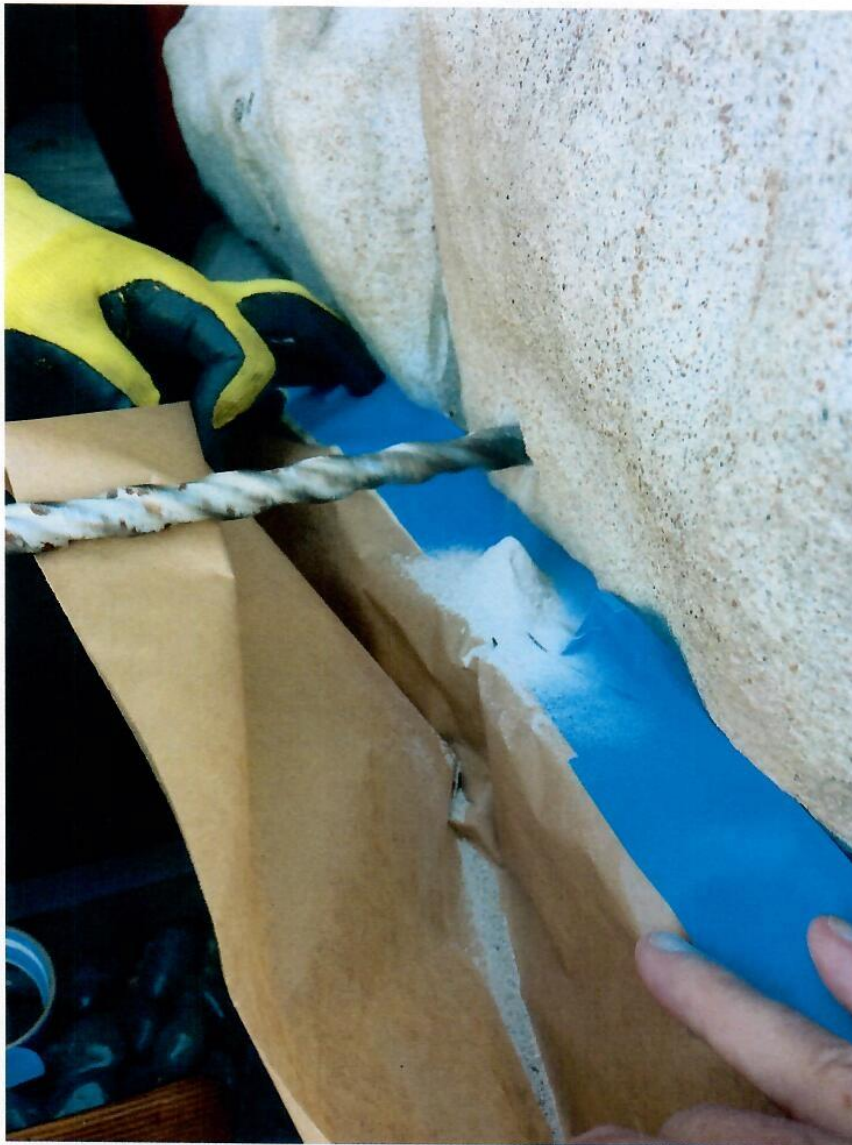
Collection of sandstone substrate utilizing USEPA SOP for Sampling Porous Surfaces for Polychlorinated Biphenyls, Section 9.1.4
